Project Area 2

Bacteria Impairments

TMDL

Segment 1806 – Guadalupe River

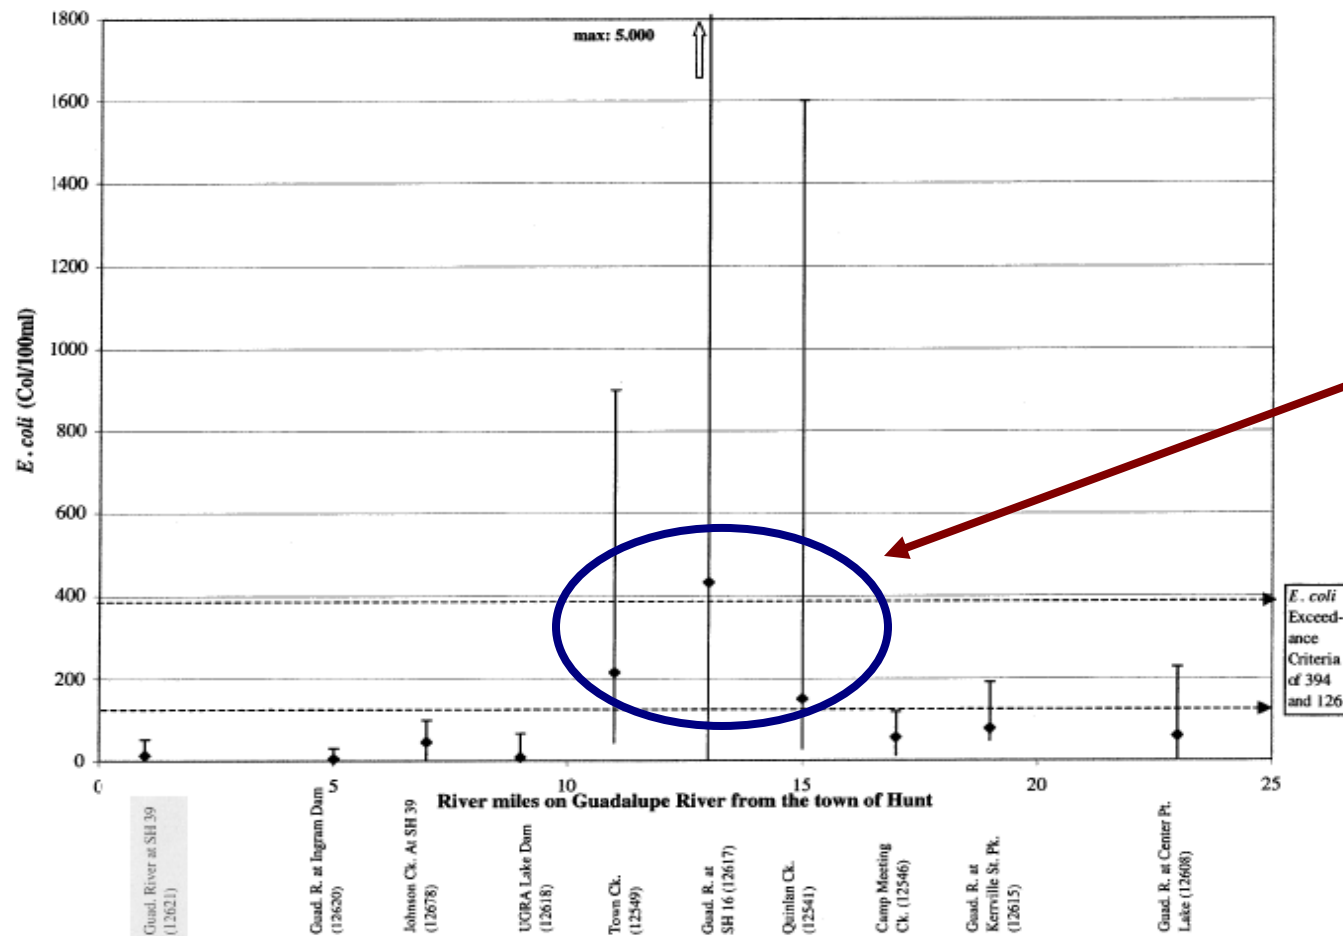
Figure 2-2
Guadalupe River *E. coli* Sampling Means, Routine Events of 15 February - 2 August 2005

Town Creek,
SH 16, and
Quinlan Creek

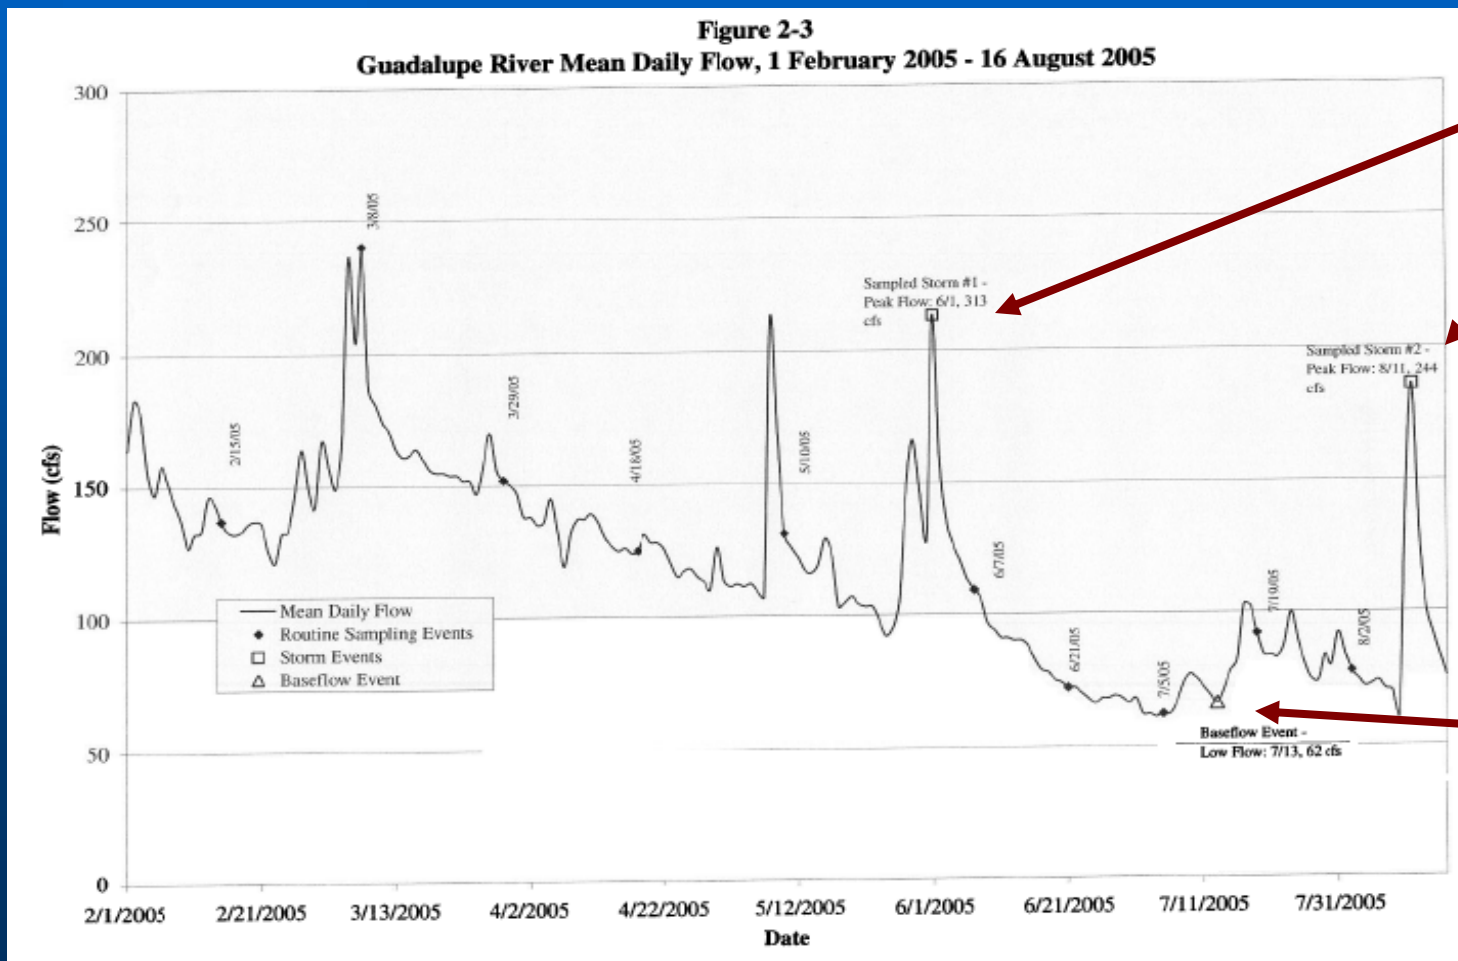
Mean Daily Flow – Feb – Aug 2005

1st Storm Event

2nd Storm Event

Baseflow Event

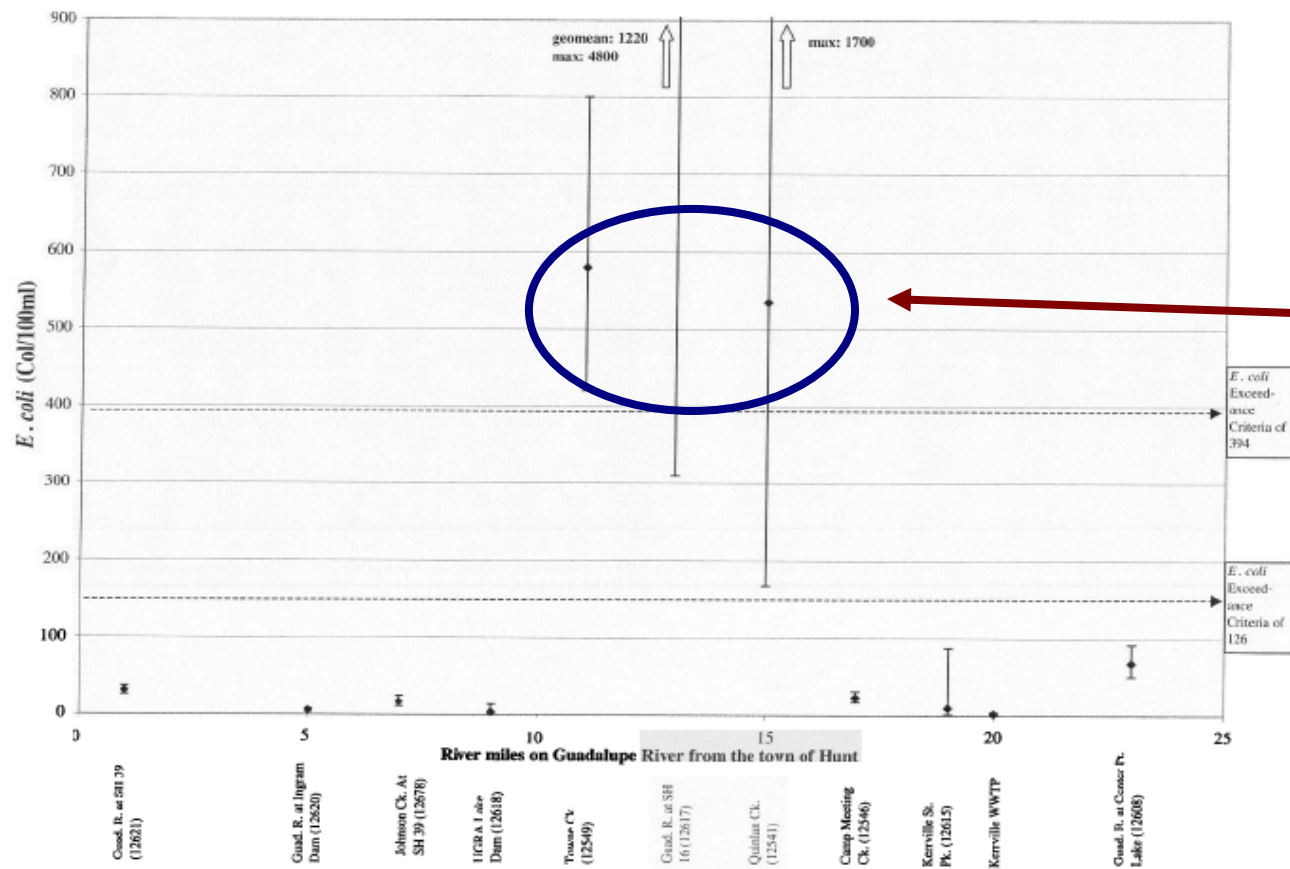
Figure 2-4
Guadalupe River *E. coli* Sampling Means, Baseflow Event of 13 July 2005

Town Creek,
SH 16, and
Quinlan Creek

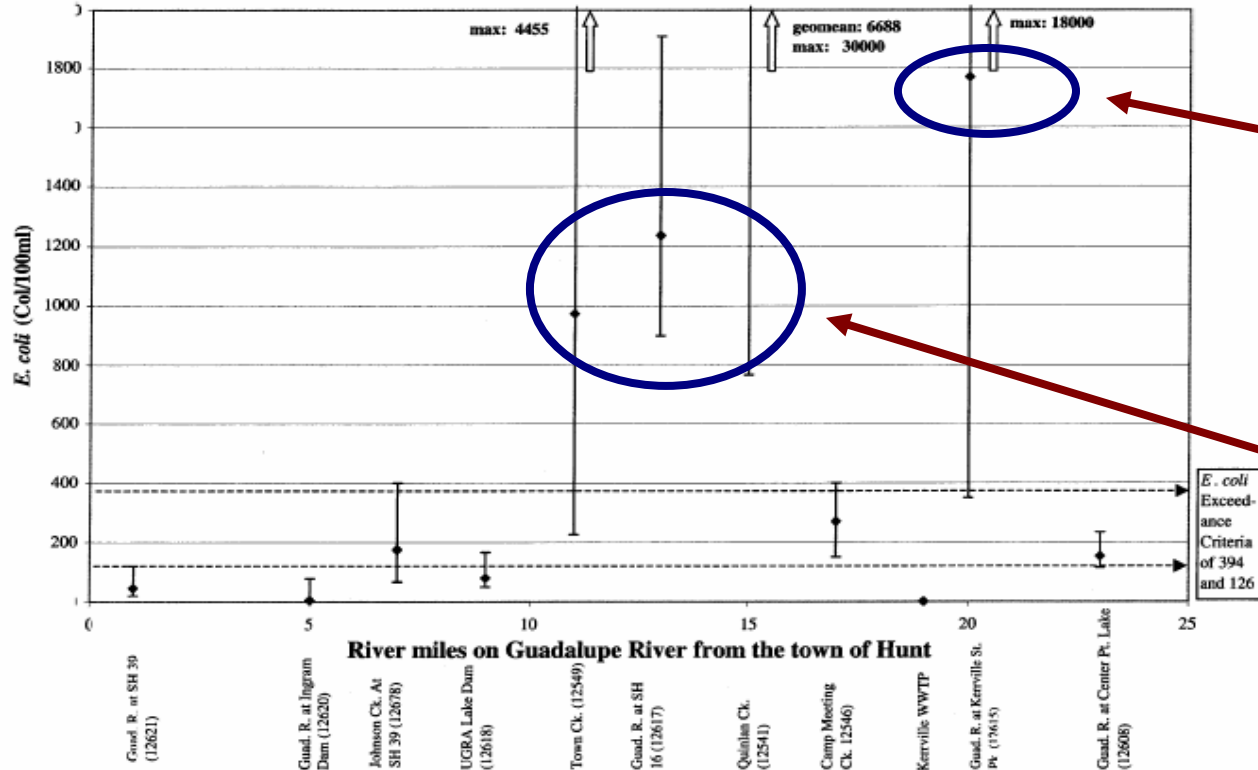
Figure 2-6
Guadalupe River *E. coli* Sampling Means, Runoff Event of 1-2 June 2005

Kerrville
Street Park

Town Creek,
SH 16, and
Quinlan Creek

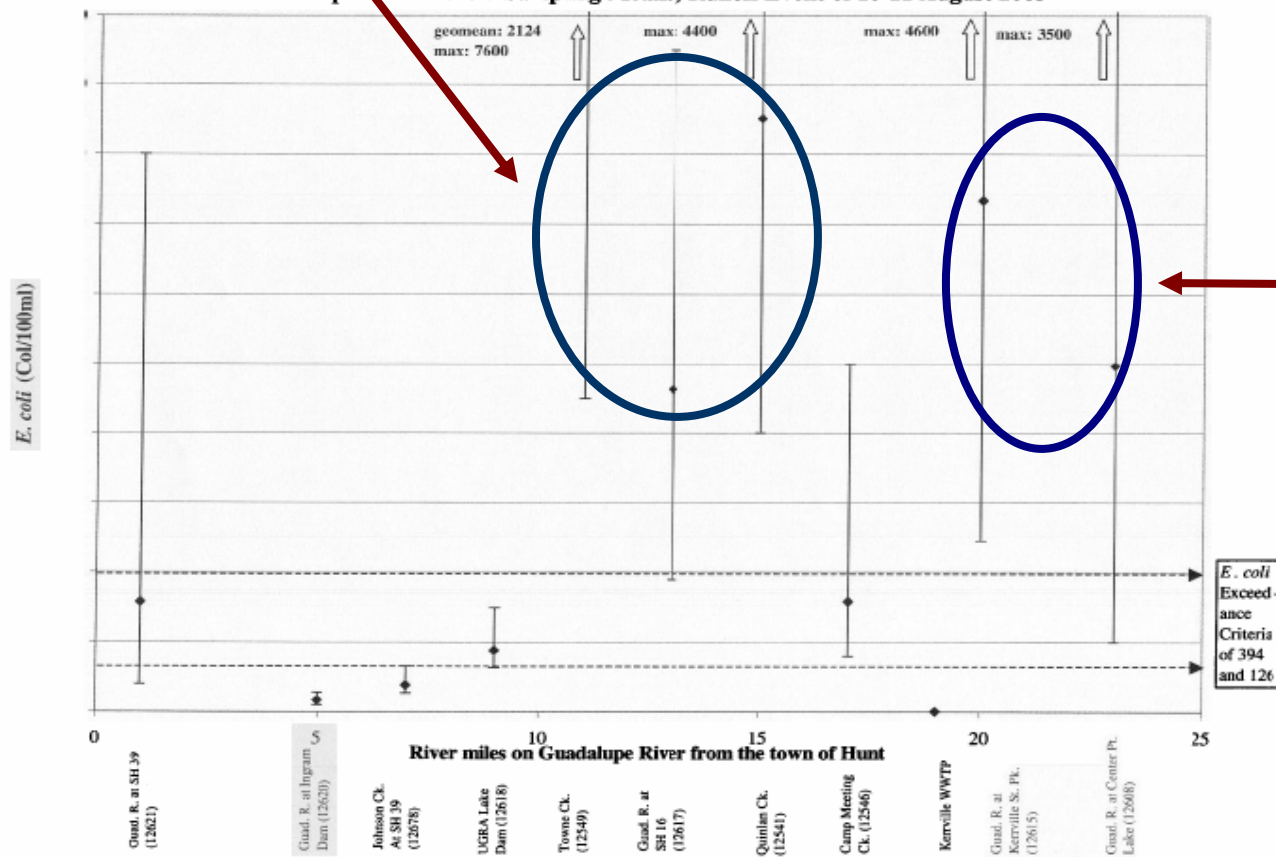
Figure 2-8
Guadalupe River *E. coli* Sampling Means, Runoff Event of 10-11 August 2005

Kerrville
Street Park
and Center
Point Lake

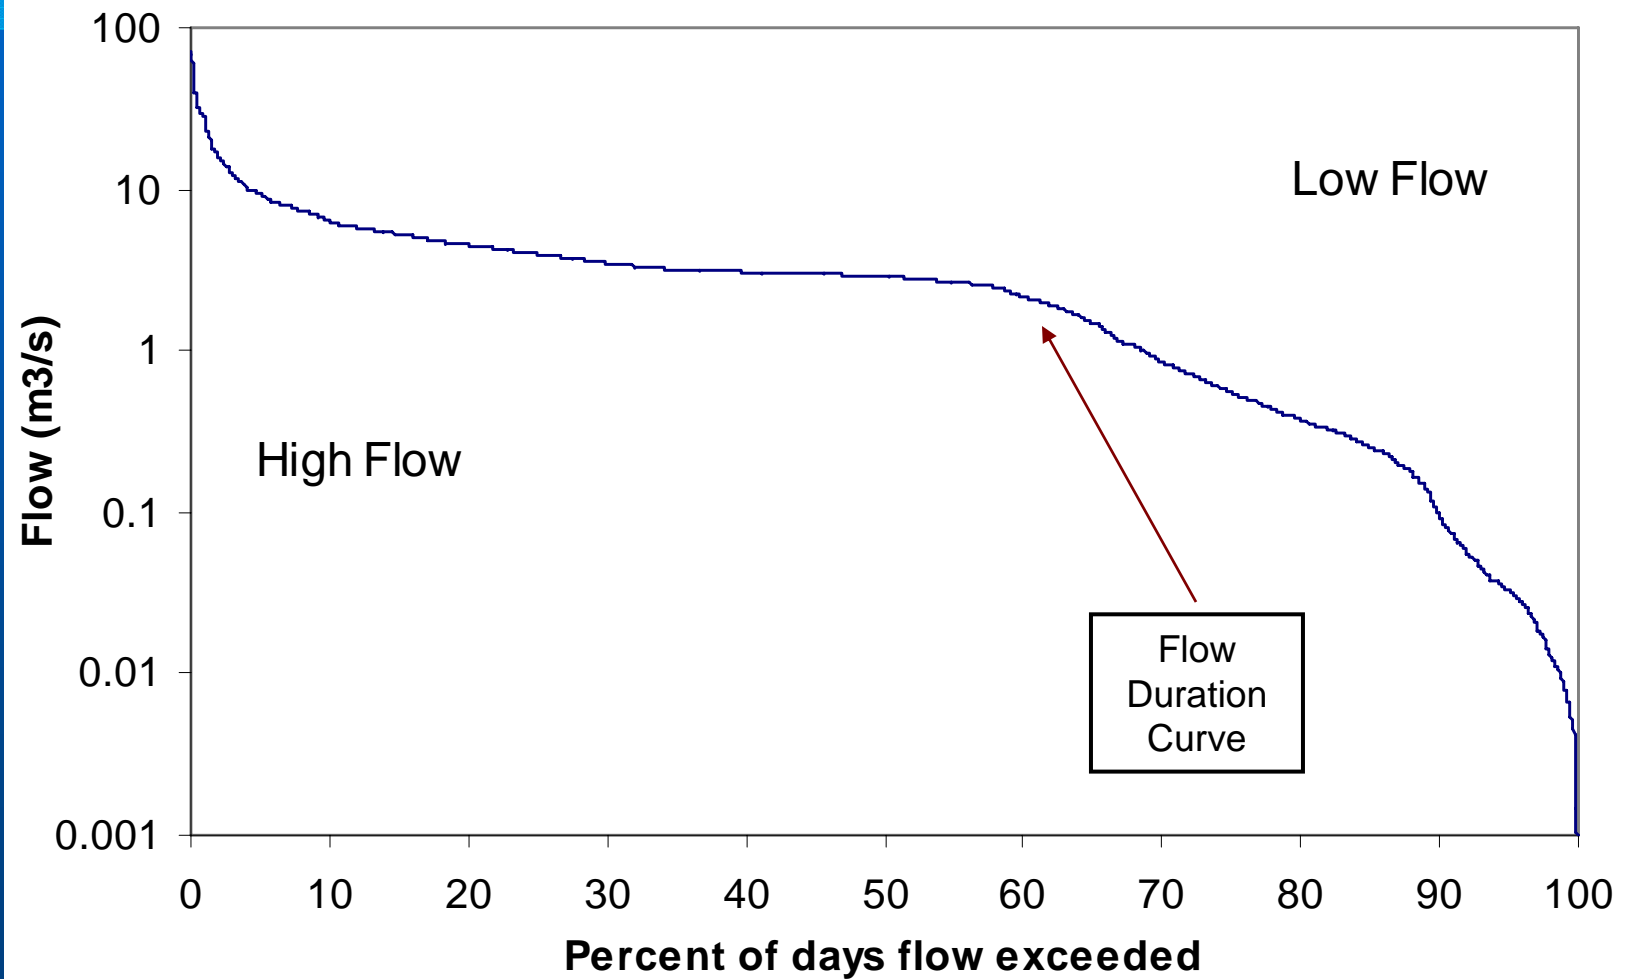
1st Step - Result

- Establish a daily record of multiple years of streamflow ranked highest to lowest to create a flow duration curve.

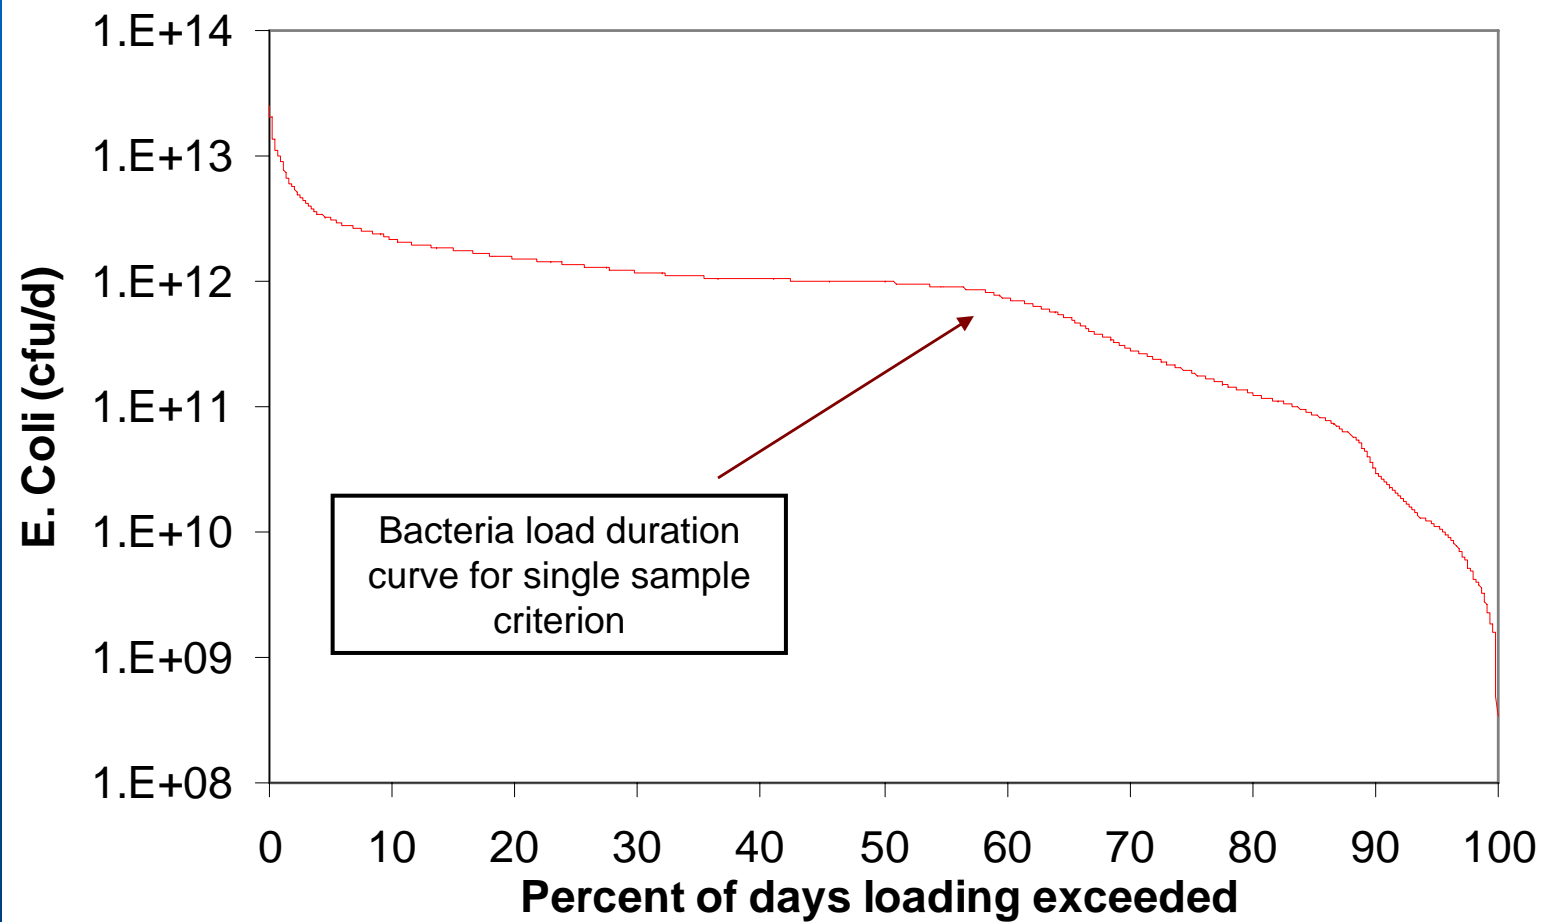
2nd Step - Result

- The flow duration curve is combined by multiplication with a numeric criterion (for this example the single sample *E. coli* criterion of 394 cfu/100 ml.)

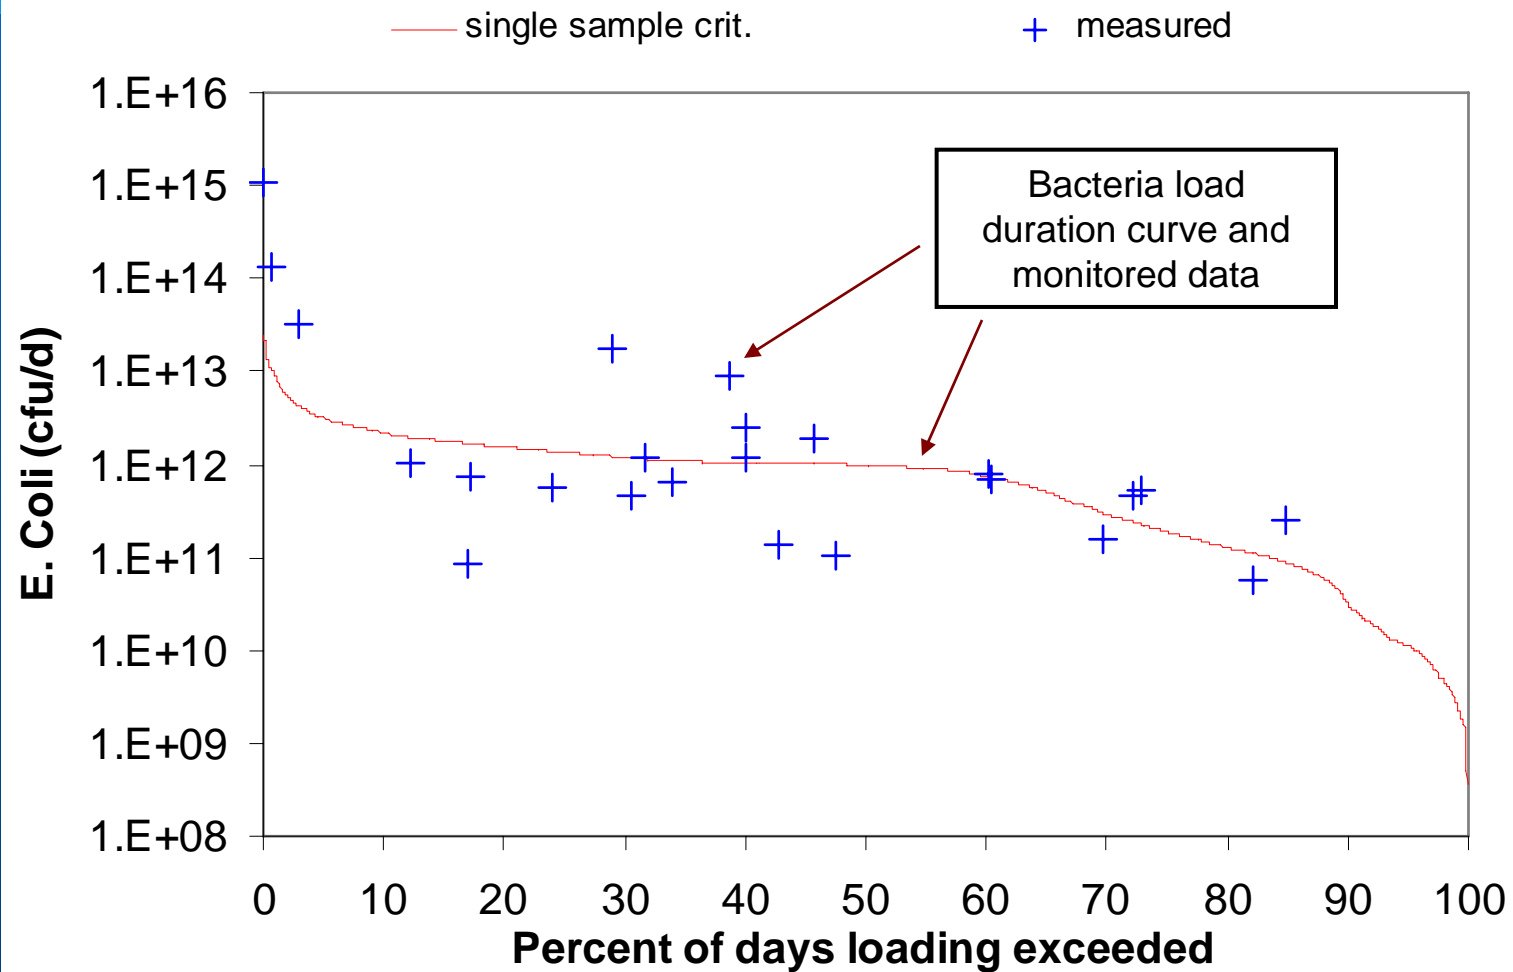
3rd Step Results

- The existing *E. coli* concentration data for specific days are multiplied by the streamflow on that same day.
- The data used are specifically those data for a respective water quality station.

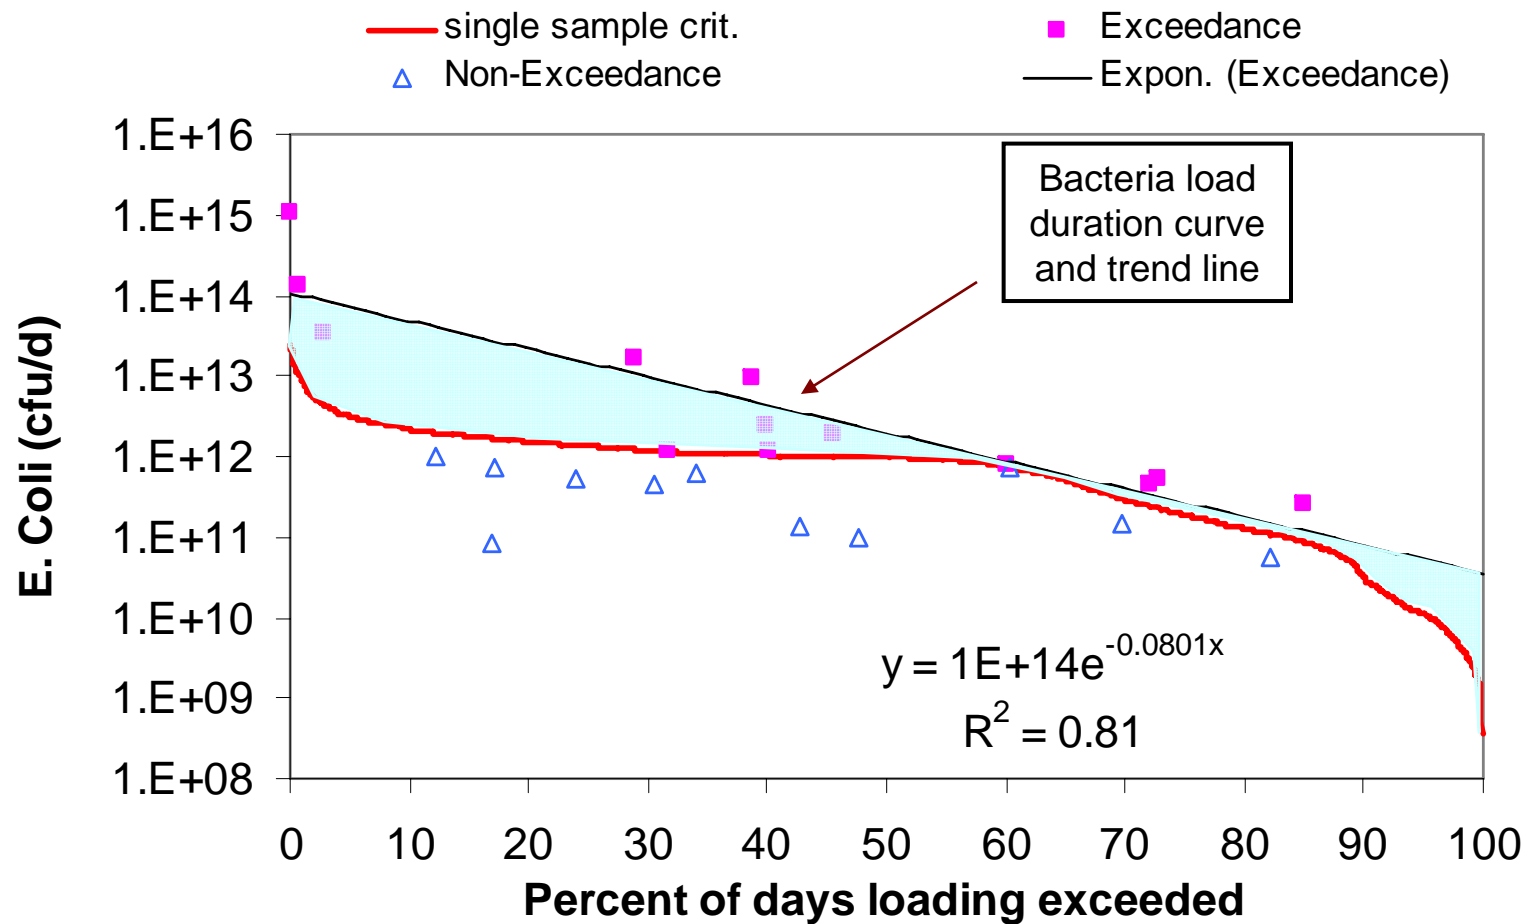
4th Step Results

- Use any one of several accepted procedures to determine exceedances to allow calculation of required percent reductions, which allows the allocation process to be quantified.
- For this example, the exceedances are determined by a **trend line** through all *E. coli* data that are greater than the criterion of 394 cfu/100 ml.

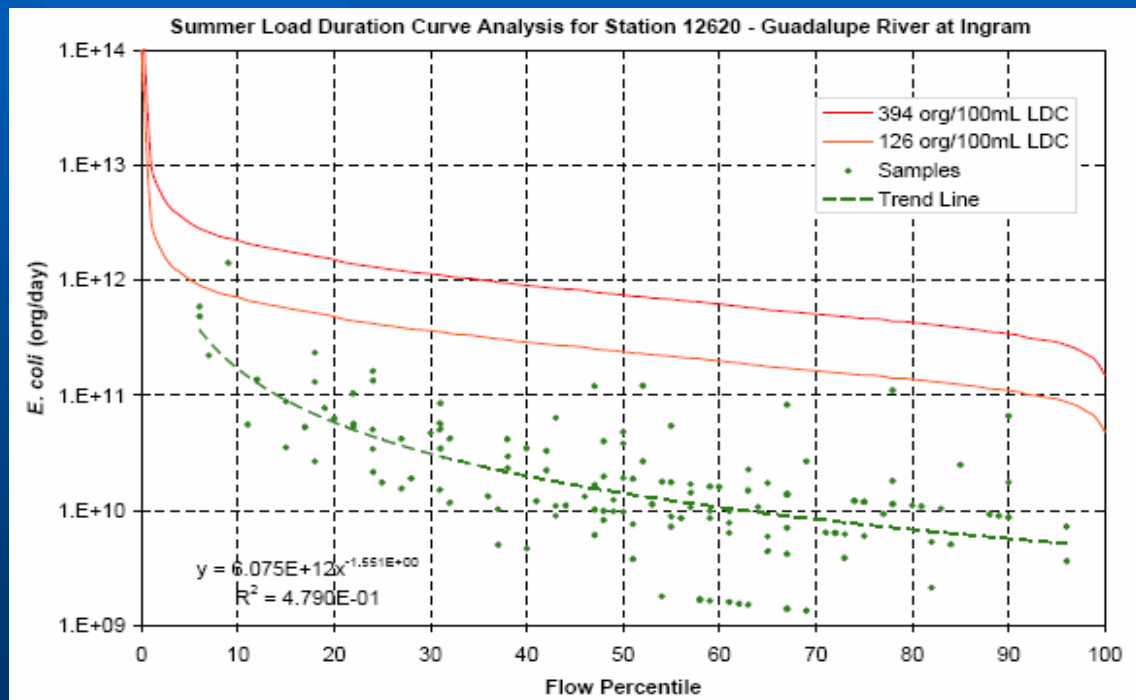
LDC for Station 12620 – Guadalupe River at Ingram

This station usually meets the state criteria. None of the historical samples exceeded the grab sample criterion of 394 org/100mL. All but one sample fell below the gm criteria of 126 org/100mL.

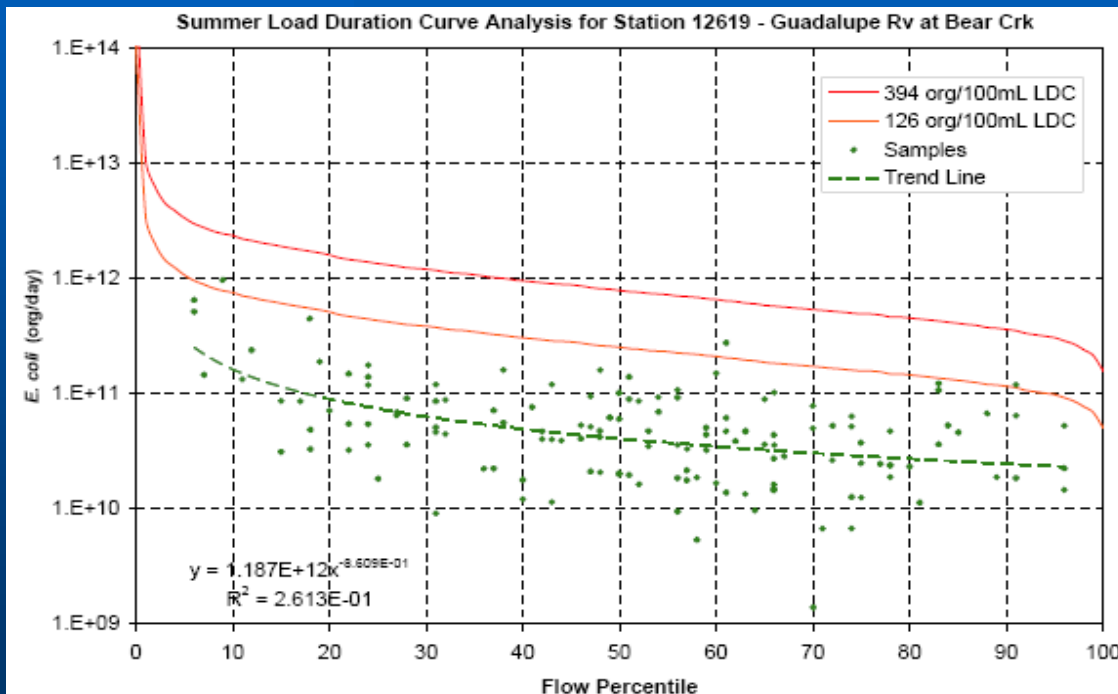
LDC for Station 12619 – Guadalupe River at Bear Creek

This station usually meets the state criteria. However, loads are higher under mid-range and low flow conditions than at the previous station. Also, this may be due to the fact that the previous station is at a dam site. Impoundments in this study seem to result in lower bacterial levels.

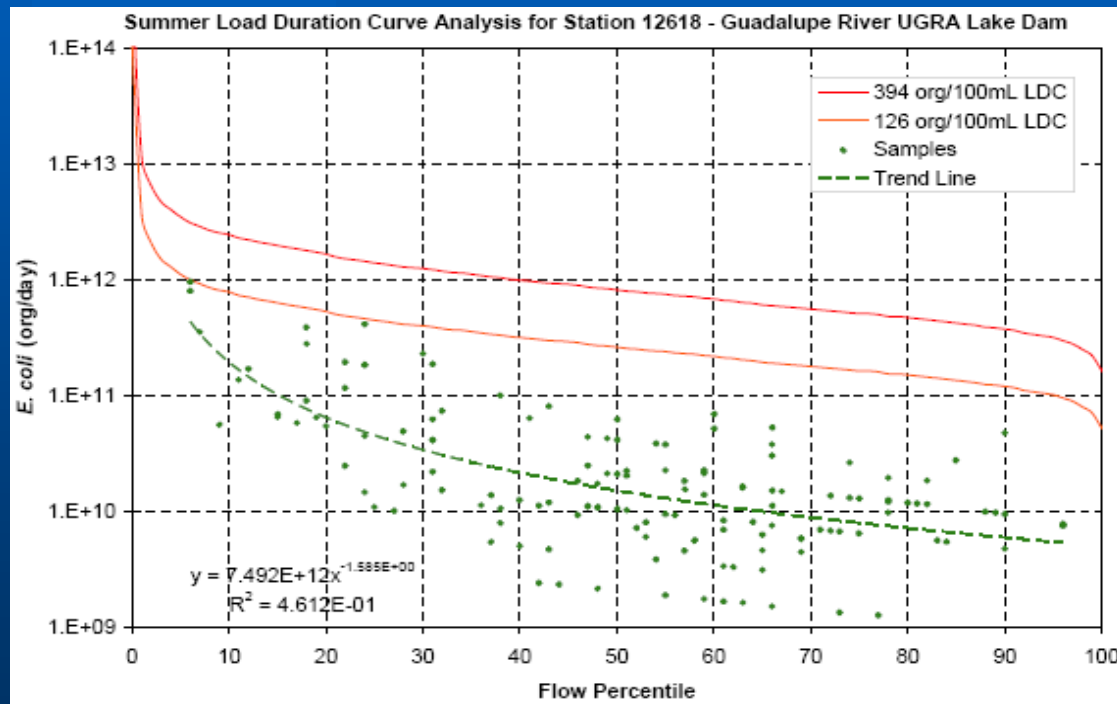
LDC for Station 12618 – Guadalupe River at UGRA Lake Dam

This station usually meets the state criteria. Loads associated with low and mid range flows are less than at the previous station. This reduction could be a result of bacteria removal that occurs as a result of the impoundment.

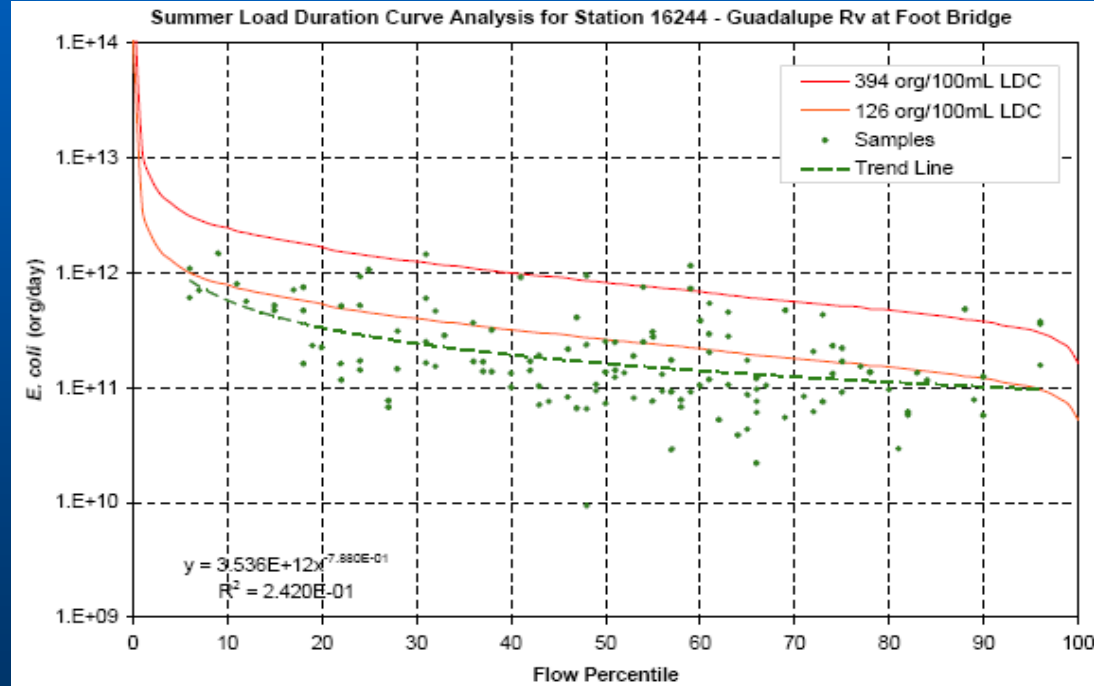
LDC for Station 16244 – Guadalupe River at Foot Bridge

Seven samples (5%) exceed the grab sample criterion and a **large number exceed the gm criterion**. Loads at low and mid range flows are 10 times higher than at the previous upstream station. This suggests that a significant dry weather direct source exists between the two stations.

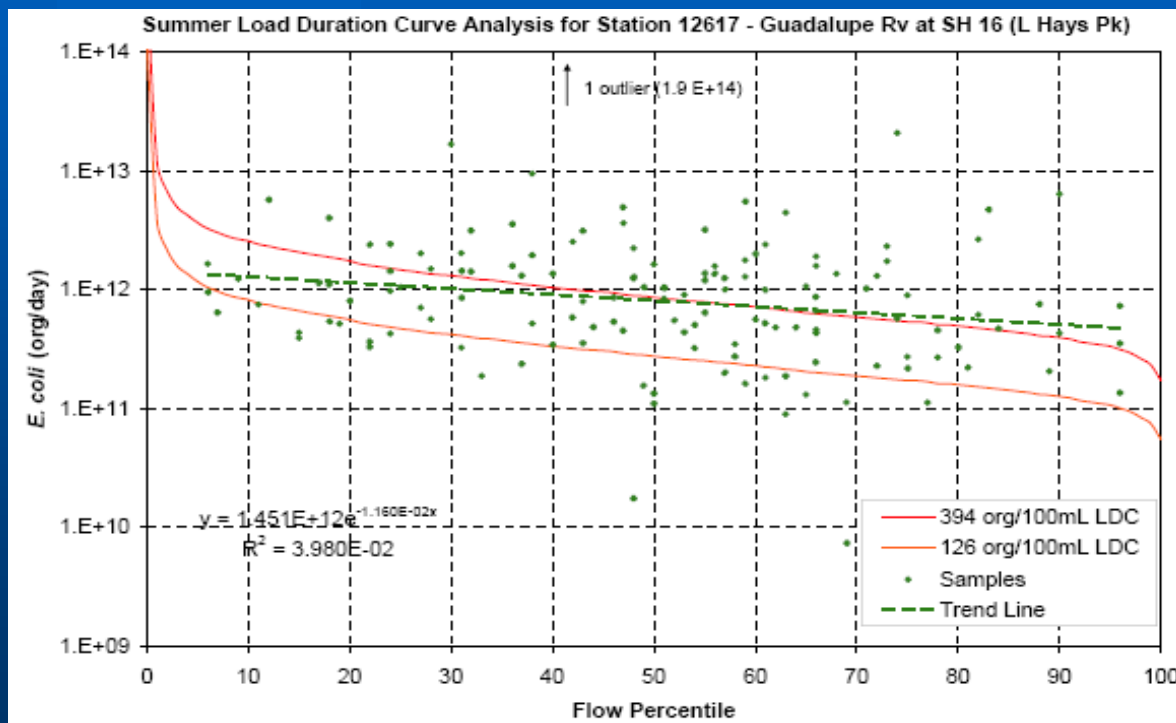
LDC for Station 12617 – Guadalupe River at Hwy 16 in L. Hays Park

Concentrations at this station are typically higher than at any other station in this study. 46% of the samples exceed the grab sample criteria. The greatest exceedances in criteria are now experienced during low flow. This suggests that the station is influenced by significant dry weather direct sources.

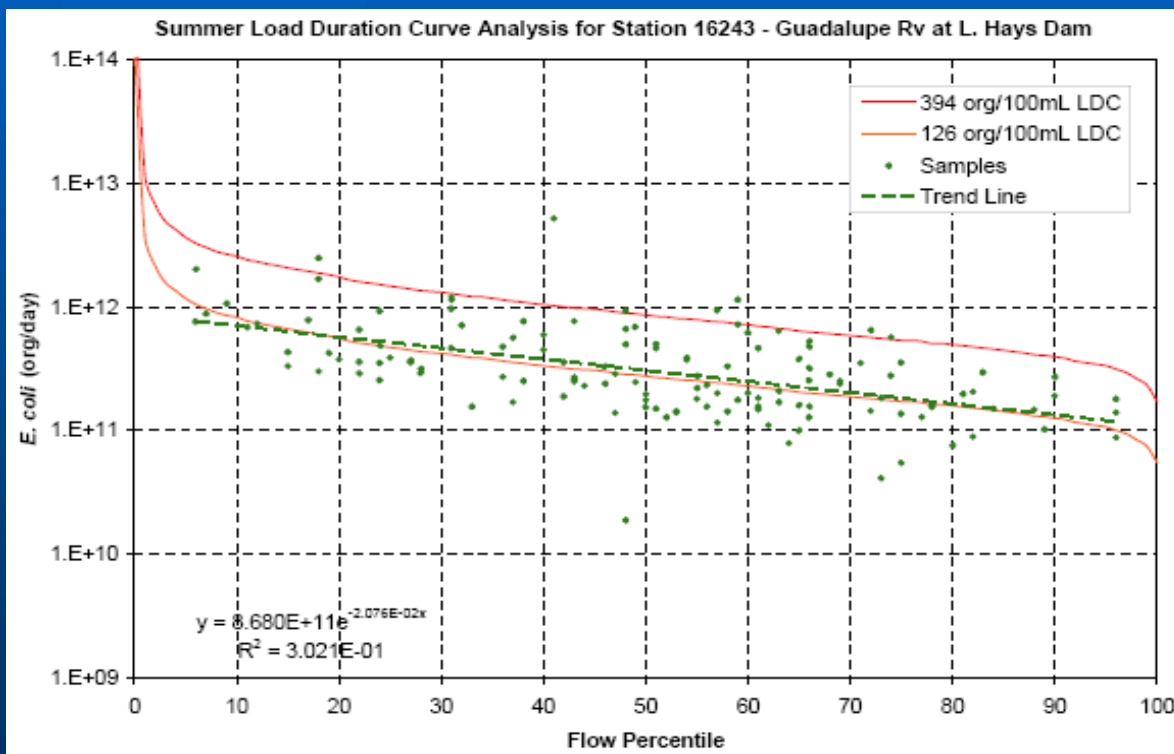
LDC for Station 16243 – Guadalupe River at L. Hays Park Dam

Just 7 samples, 5% exceed the grab sample criterion. However, the trend line suggests that the gm is often exceeded. The impoundment of water provided by the dam results in a positive influence on bacterial water quality. Previous stations at Ingram Dam and UGRA Dam also exhibited relatively low bacteria levels with relatively little scatter.

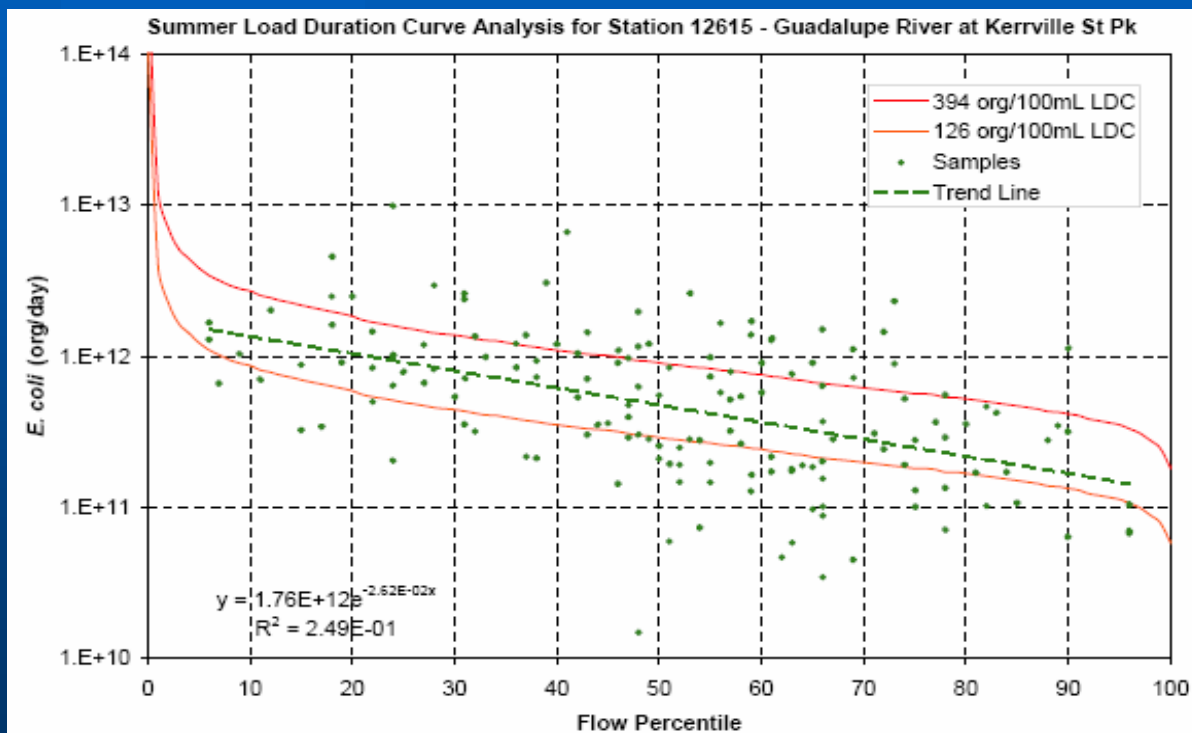
LDC for Station **12615** – Guadalupe River at **Kerrville State Park**

24% of samples exceed the grab sample criterion. The trend line is significantly higher than the gm. Loads are significantly higher than at the upstream station under both low flow and high flow conditions. This suggests that both dry weather and wet weather sources are likely to exist between L. Hays Park Dam and the State Park.

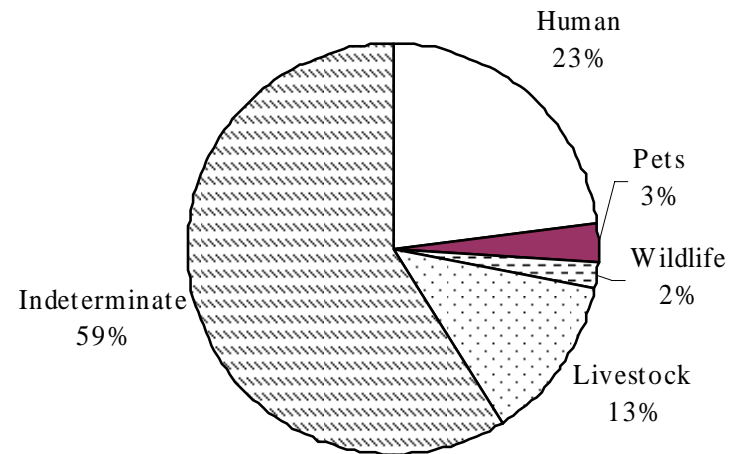
Bacteria Source Composition @ Station 12621 – Guadalupe River at SH 39

**Bacterial Source Tracking Results at Station 12621, Guadalupe River
at SH 39**

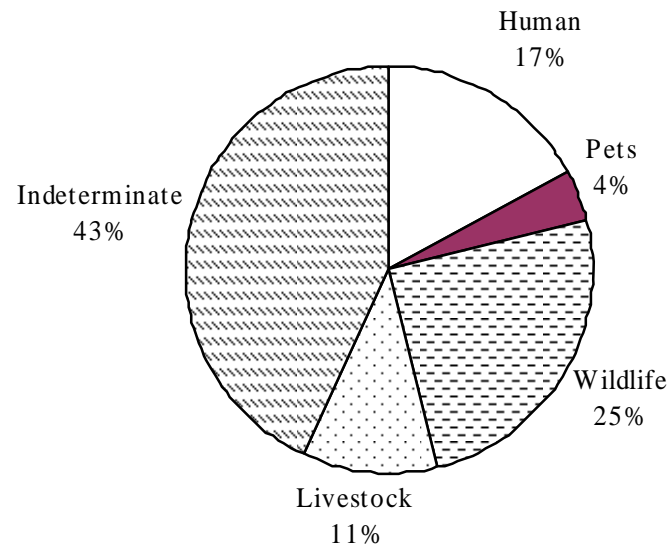
Bacteria Source Composition @ Station 16243 – Guadalupe River at L. Hays Park Dam

**Bacterial Source Tracking Results at Station 16243, Guadalupe River
at L. Hays Park Dam**

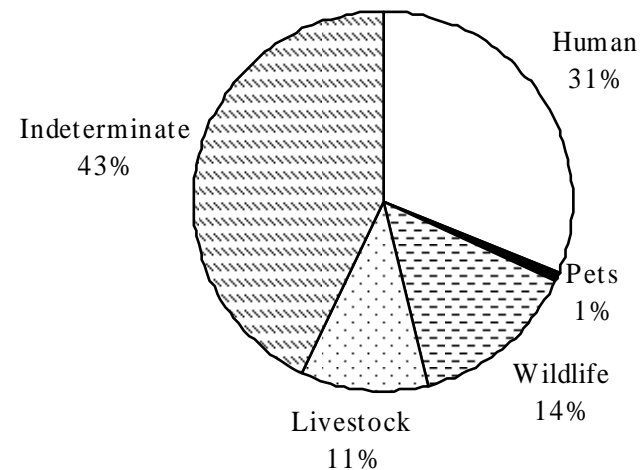
Bacteria Source Composition @ Station 12546 – Camp Meeting Creek

**Bacterial Source Tracking Results at Station 12546, Camp Meeting
Creek**

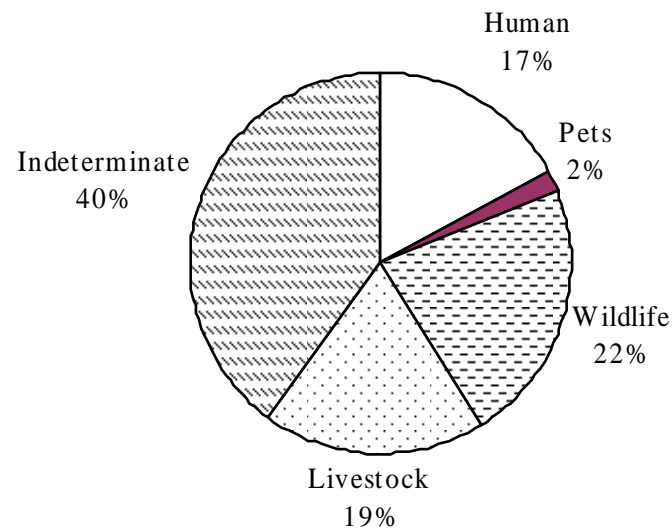
Bacteria Source Composition @ Station 12615 – Kerrville State Park

**Bacterial Source Tracking Results at Station 12615, Guadalupe River
at Kerrville State Park**

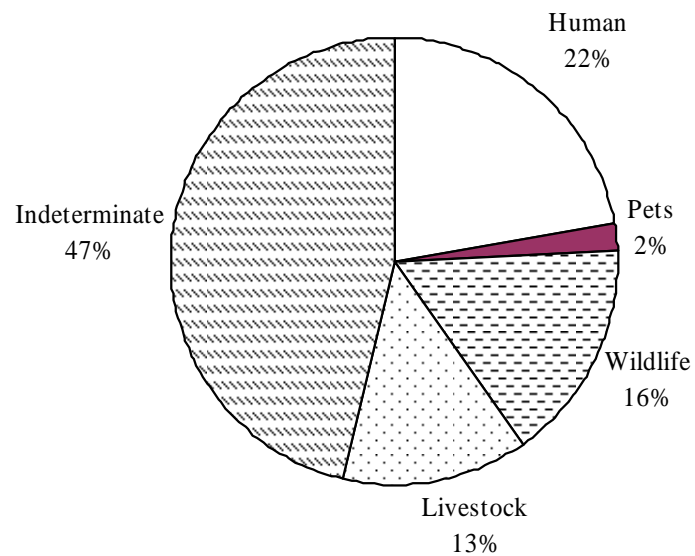
BST Results – All Stations Combined

Bacterial Source Tracking Results for All BST Stations
